AAFEX Status Report #6 – 25 January 2009

Primary Activities: Rake, inlet, and sample line leak checking; manifold construction; line loss measurement; black carbon instrument inter-comparison; 200-m trailer instrumentation;

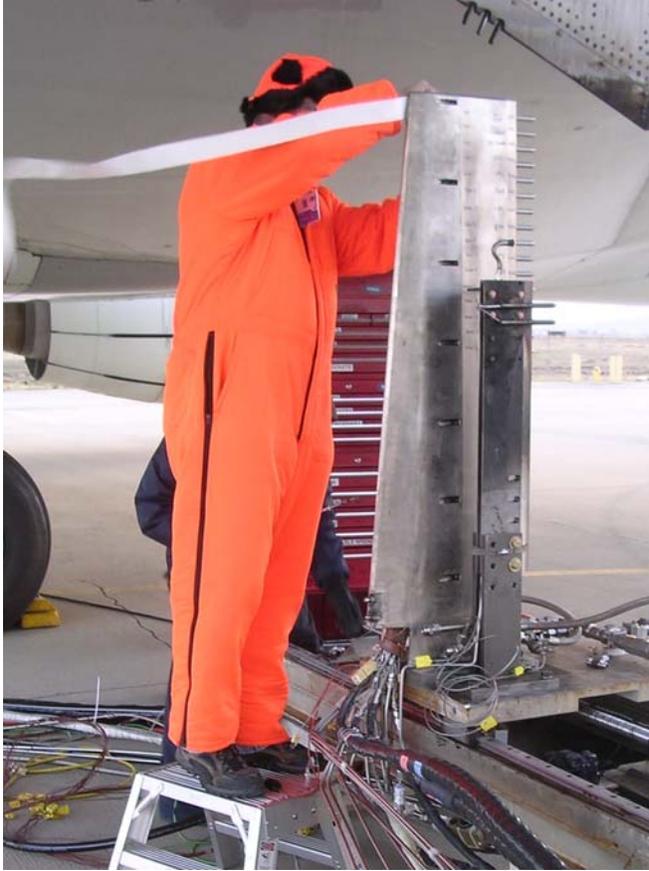
Figure 1. Dressed appropriately, Roy hunts for leaks in #3 engine rake before installing the remaining rear rake cover. Unfurled insulation tape illustrates the windy, uncomfortable conditions that prevailed throughout the day.

- Tubing connections between the 1-m rakes, valve boxes and equipment trailers was completed; leak checking, insulation of gas lines, and ringing-out all lines to determine inlet-tip/sample valve correspondence began (Figures 1 and 2).

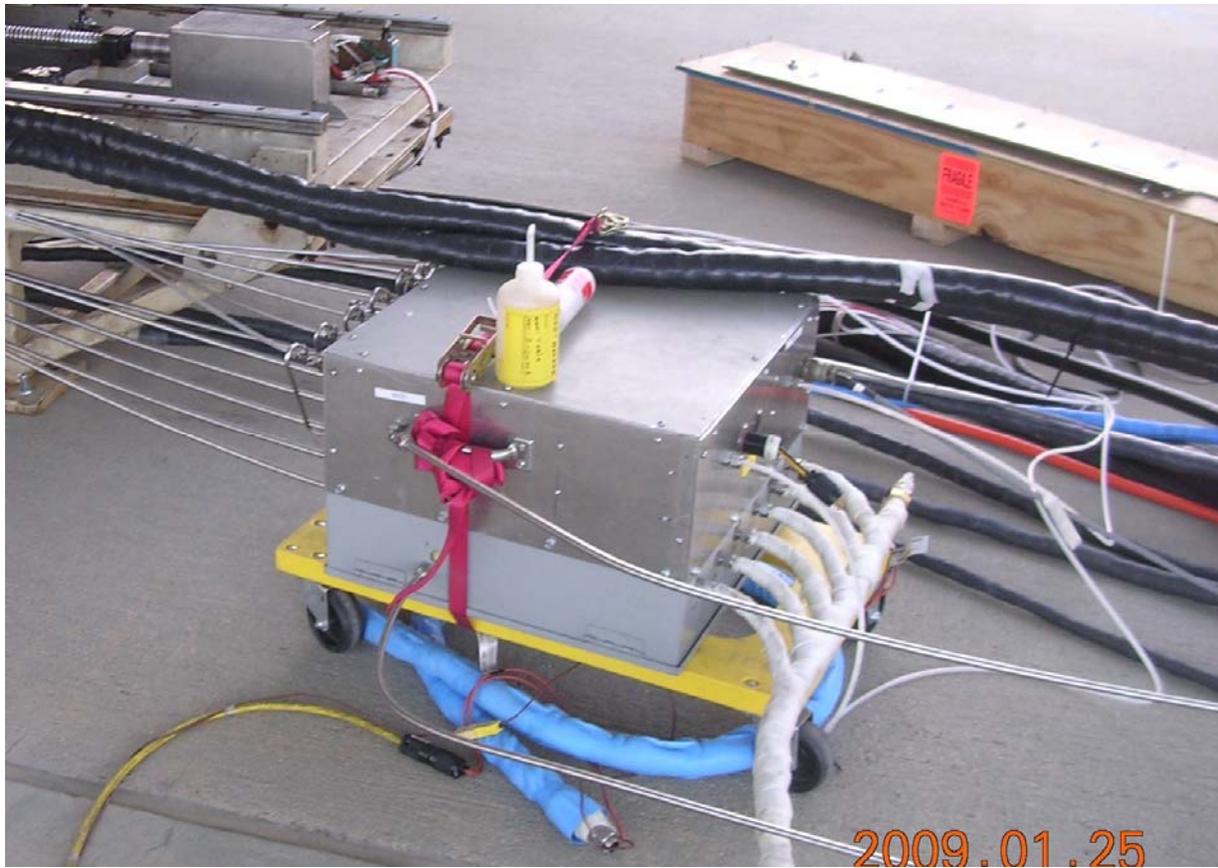
Figure 2. Six-port valve box on aerosol sample lines emanating from the #3 engine rake.

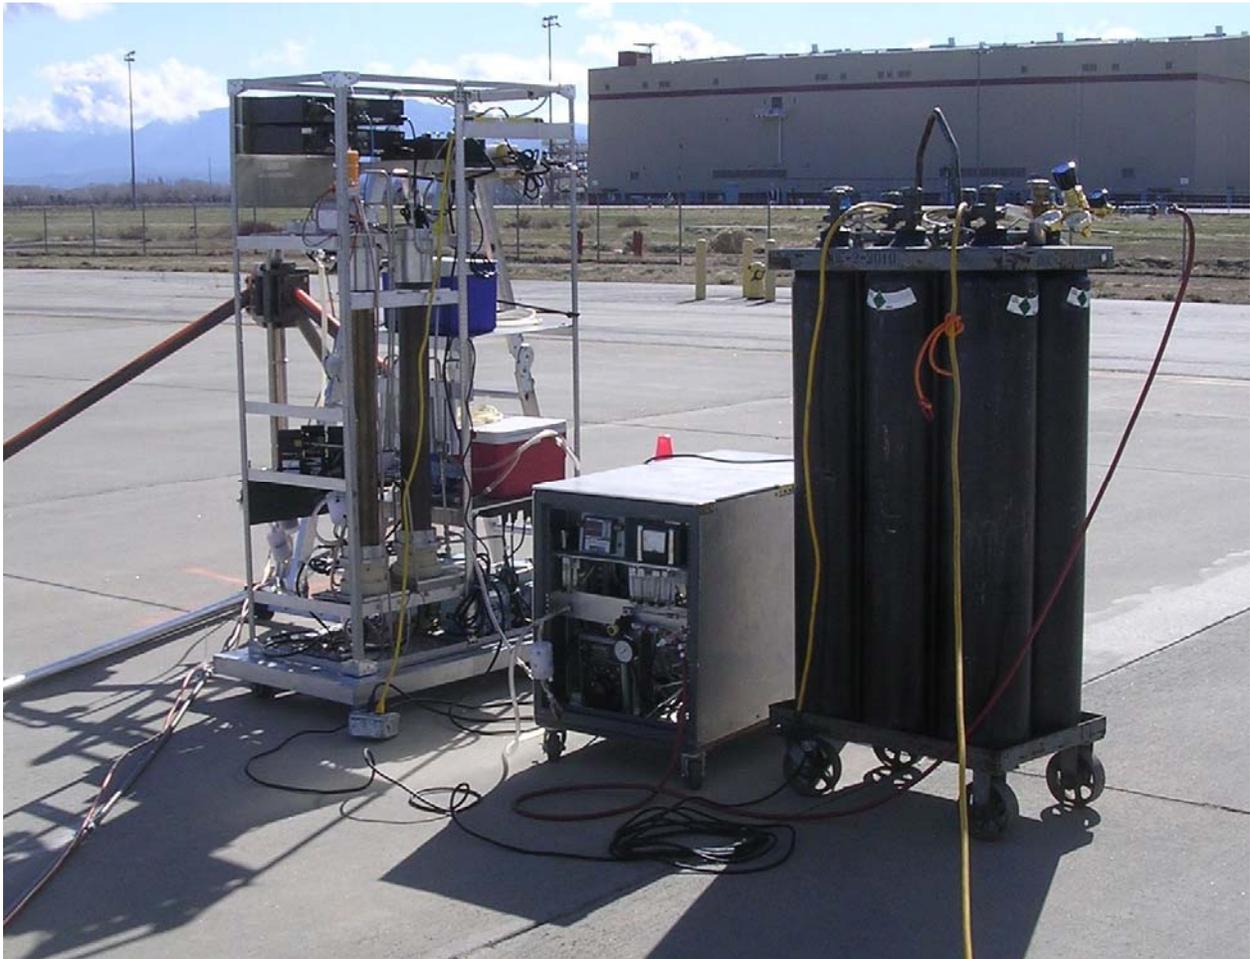
Figure 3. MST monodisperse particle generator used in the line-loss assessments.

- Max and Elizabeth set up the MST monodisperse aerosol generator behind the aircraft and evaluated size-dependent particle losses in the EPA, 2" diameter sample transport tubes as well as the 3/4" diameter common 30-m inlet lines. They were real troopers to stick with the tests, given the cold, blustery conditions they encountered (Figure 3).

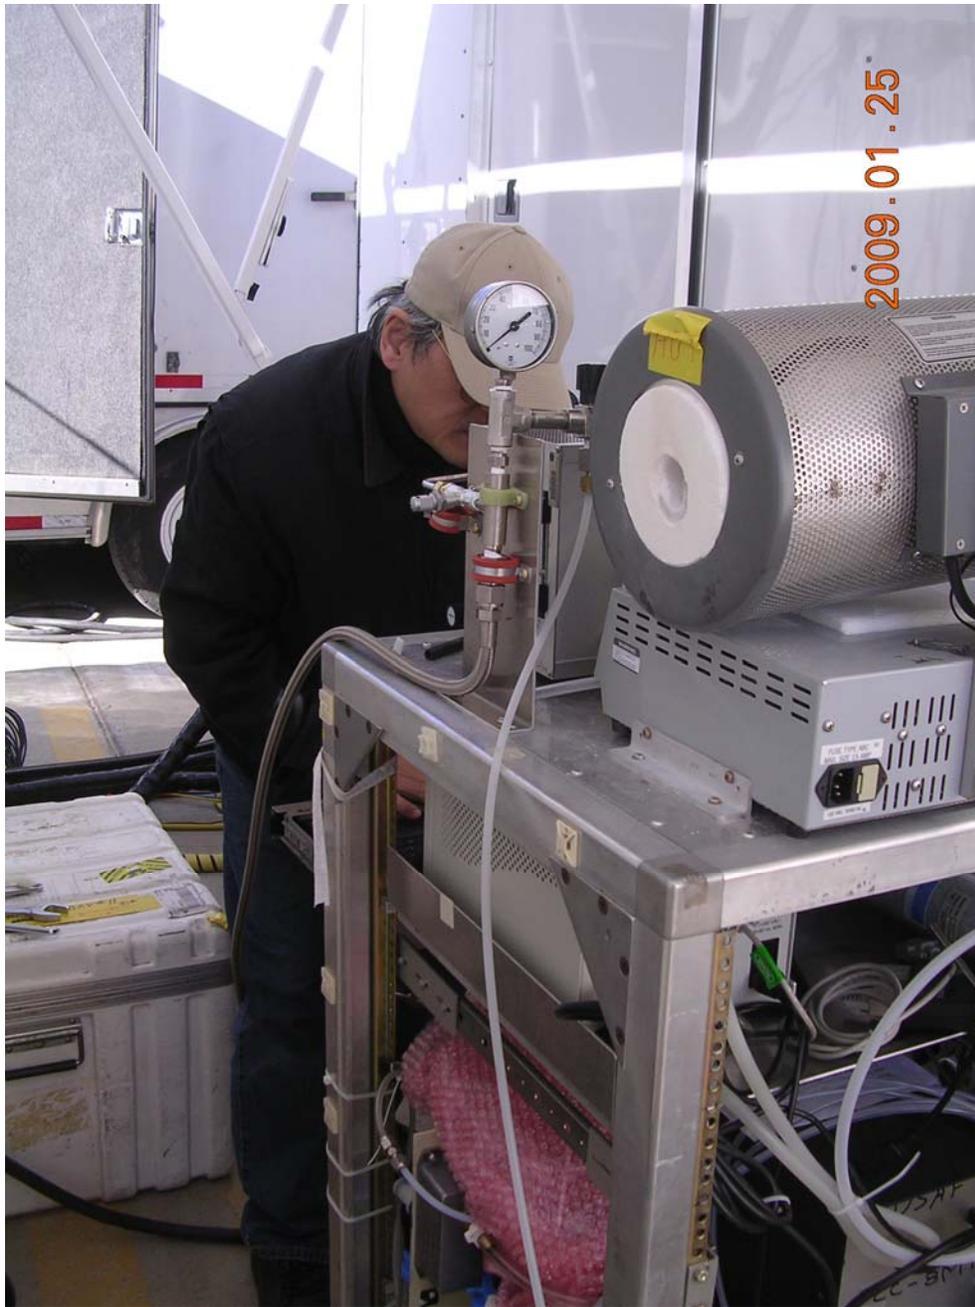
Figure 5. Changlie sets up the combustion aerosol generation system (CAST) for black-carbon instrument inter-comparisons.

- A CAST (combustion aerosol standard) system was set up near the MST sample distribution manifold and used to challenge black carbon sensors located in the LaRC, AEDC, AFRL, EPA and ARI equipment trailers. These instruments included four Multi-Angle Aerosol Photometers (MAAPs), a Tapered Element Oscillating Microbalance (TEOM), a Laser-Induced Incandescence spectrometer (LII), and a photo-acoustic aerosol absorption photometer. Samples were also collected for EC/OC analysis by off-line, thermo-optic techniques. Soot aerosols ranging from 70 to 100 nm in mean diameter and from 0.1 to 2.5 mg/m³ in concentration were tested.
